Glen Oaks Community College

Five-Year Capital Outlay Plan

**Submitted
October 2023**

Glen Oaks Community College Five-Year Capital Outlay Plan 2024-2028

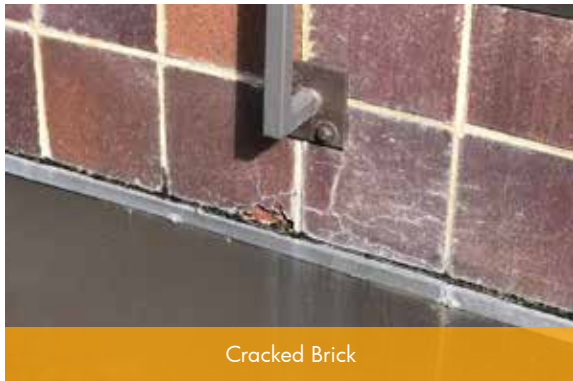
Cracked Brick

shows evidence of cracked brick units, spalled units, efflorescence, loss of mortar adhesion and missing mortar. These deformations are potentially the result of several factors and may include the following:

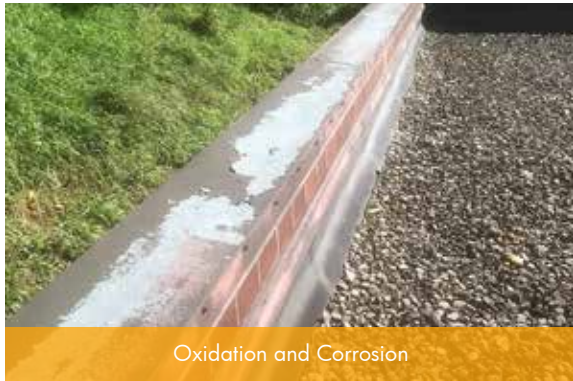
Oxidation and Corrosion

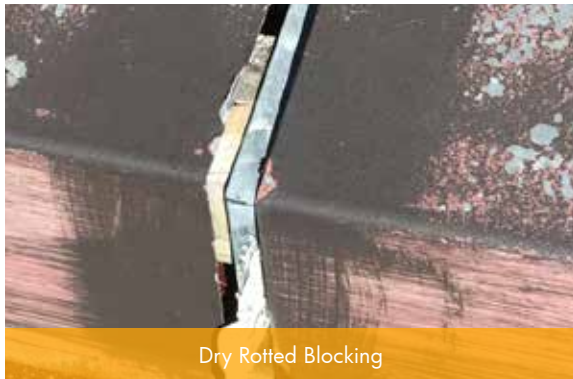
Dry Rotted Blocking

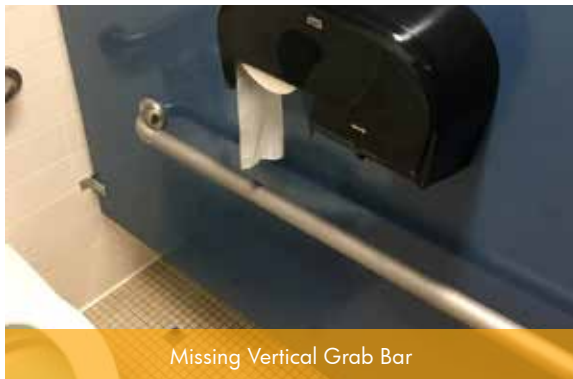
Missing Vertical Grab Bar

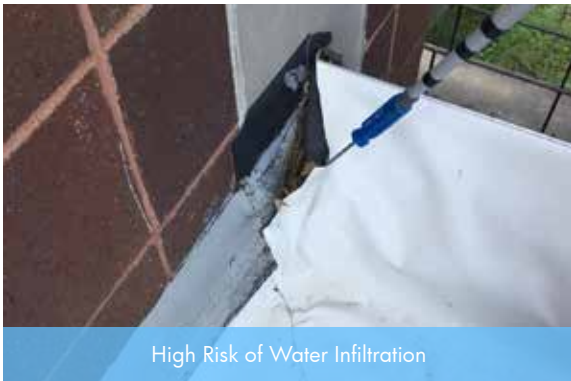
High Risk of Water Infiltration

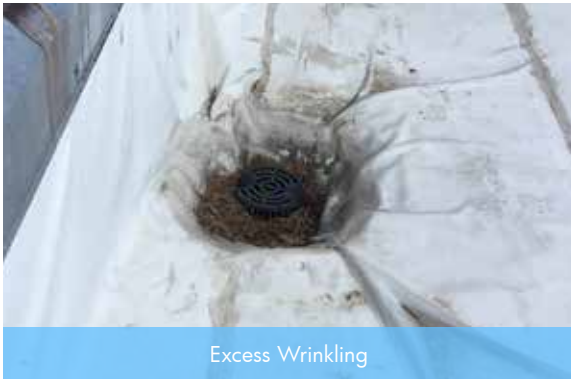
Excess Wrinkling

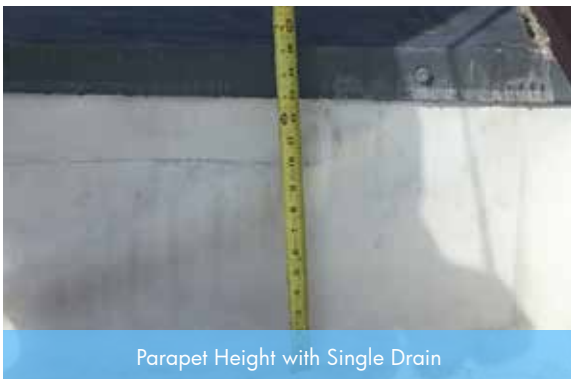
Parapet Height with Single Drain

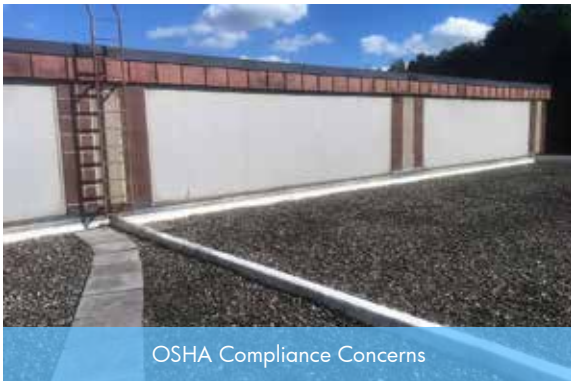
OSHA Compliance Concerns

7. Several of the existing roof access ladders are awkward to use and navigate. Although these ladders were likely code and OSHA compliant at the time of construction the ladders no longer meet current OSHA standards and requirements. It is recommended as part of a reroofing project that existing ladder locations be considered for replacement to be in compliance with current OSHA access ladder design requirements.

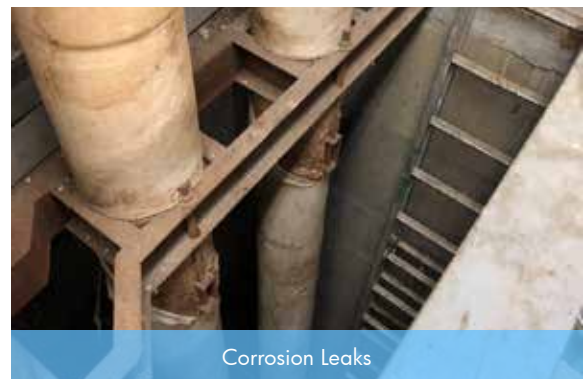
Corrosion Leaks

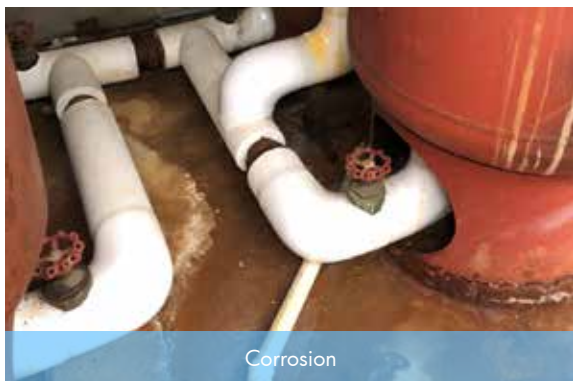
Corrosion

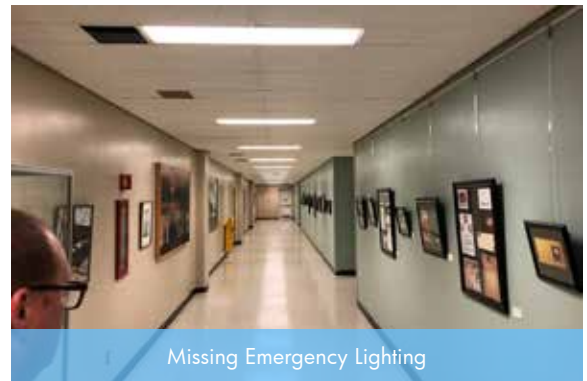
Missing Emergency Lighting

egress to be the area on the exterior that leads people away from the building. At the time of our survey, we did not see any emergency egress lighting on the exterior of the building. This is not an immediate safety issue, but it should be addressed as part of any building renovation.

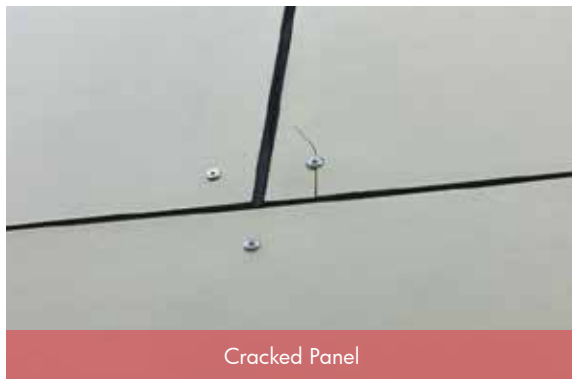
Cracked Panel

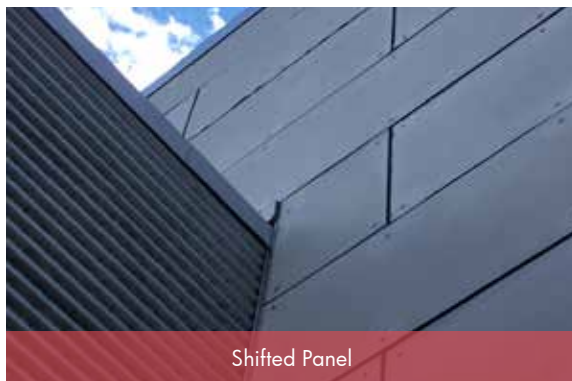
Shifted Panel
