Glen Oaks Community College

Five-Year Capital Outlay Plan

**Submitted
October 2023**

Glen Oaks Community College Five-Year Capital Outlay Plan 2024-2028

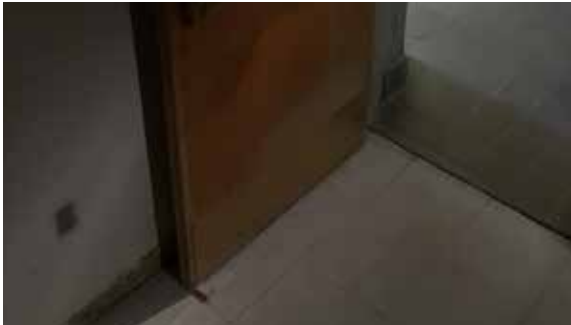
Life Safety

It was noted that door wedges are being used to hold open rated doors at some locations.

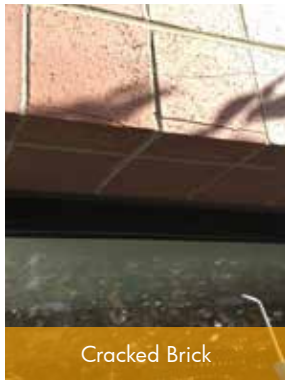
The only visibly cracked or damaged brick is located at the head of the recessed windows just to the east of the south facing entry doors. The brick extends down and forms the soffit above the windows. There a couple locations where the corner brick has cracked likely due to water infiltration below the through wall flashing. While this does not represent a serious structural concern, the damaged brick should be replaced. Water infiltration at these locations has the potential to damage the window soffits. Recommend masonry restoration to correct damaged areas and evaluate through wall flashing condition at this location.

Cracked Brick

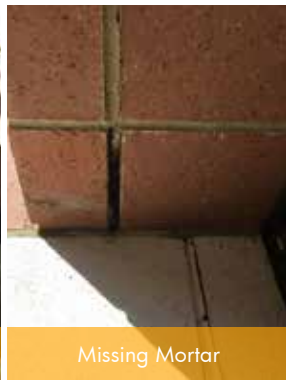
Missing Mortar

There are a few locations on the underside of the brick soffit that sections of mortar have fallen out of the joint. The vertical mortar joint adjacent to the window systems has also cracked for the full length of the joint. This mortar joint should be removed and replaced with backer rod and sealant.

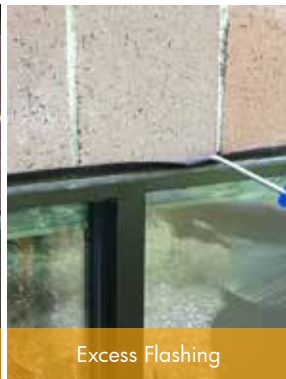
Excess Flashing

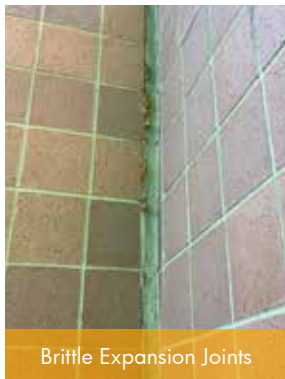
Brick control joint caulking in most of the original and 1992 building area is brittle or has shown instances of both cohesive failure and adhesive failure and should be replaced with new backer rod and compatible sealant. Water infiltration at these joints has the potential to damage infiltrate the wall cavity and cause damage to the underlying substrate or damage the brick veneer through cycles of freeze/thaw.

Brittle Expansion Joints

Building expansion joints need replaced. The material is brittle and has signs of both adhesive and cohesive failure.

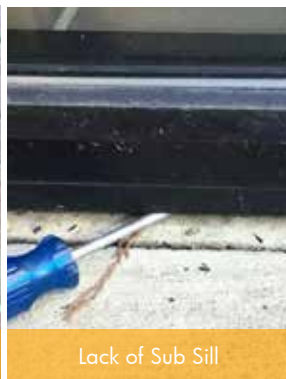
Lack of Sub Sill

Storefront systems do not appear to have a sub-sill for drainage or waterblock at sill condition. Would recommend providing backer rod and sealant behind the plane of the weeps to prevent moisture infiltration through the on-grade sill condition.

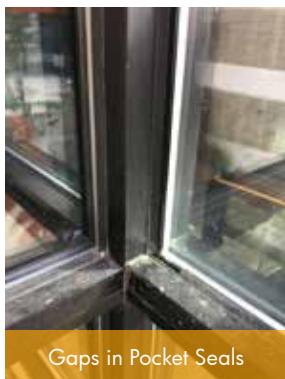
Gaps in Pocket Seals

It was noted that numerous glazing pocket seals have significant wear and shrinkage resulting in gaps. These should be replaced to keep excessive amounts of water out of the window framing system glazing pockets.

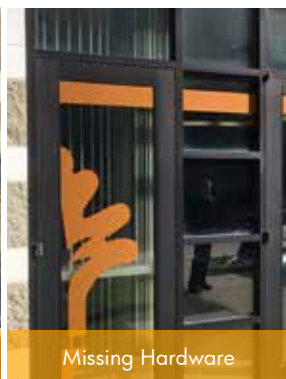
Missing Hardware

Storefront doorways on southwest side of A Wing that egress from auditorium space appear to be missing top pivot hinge hardware. These doors contain panic hardware and are part of the egress from the classroom. The doors that are missing the top hinge have sagged slightly and are rubbing at the top corner of the frame. This causes the doors to stick and require additional opening force. Ensure that doors are fully operational. [IMG_0153]

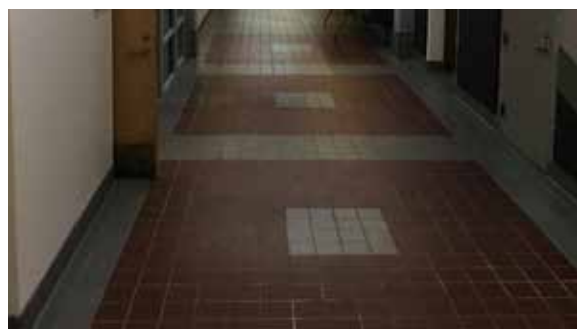
Grout Joints

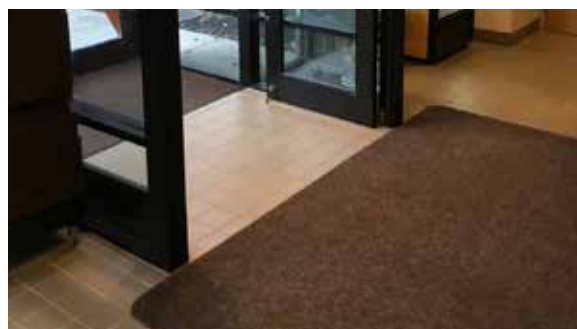
Thick Walk-off Mats

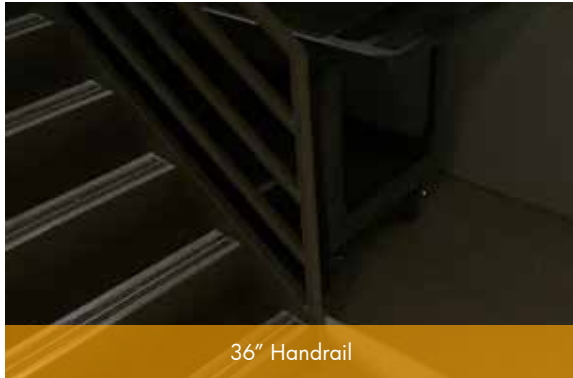
36" Handrail

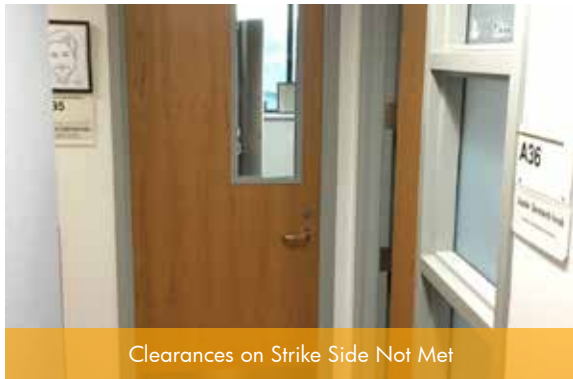
Clearances on Strike Side Not Met

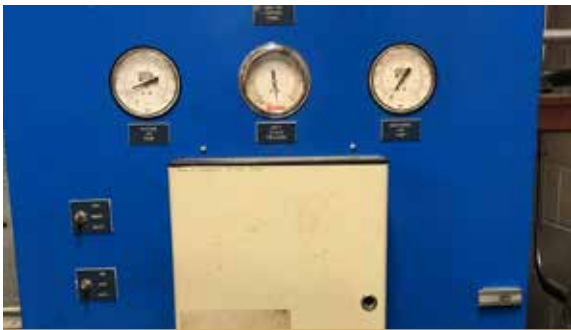
Direct Digital Controls Recommended

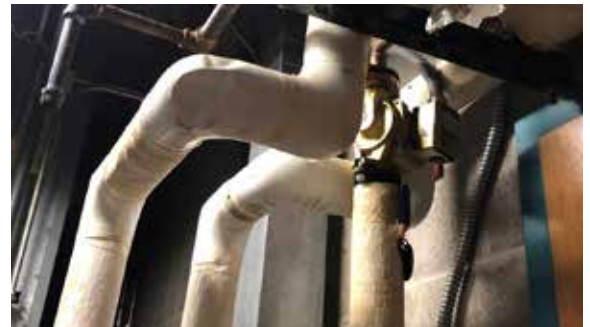
Piping in Good Condition

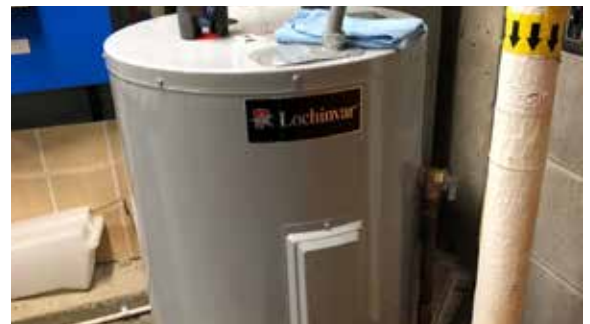
Safety Thermostatic Mixing Valve Missing

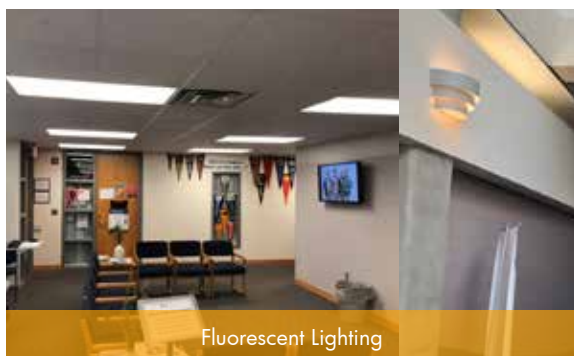
Fluorescent Lighting

Lighting throughout the A wing is primarily fluorescent. In most areas, light fixtures contain 4 ft. T8 type fluorescent lamps, or compact fluorescent lamps in can lights and wall sconces. In the areas we surveyed the light levels were adequate, and they appear to meet Illuminating Engineering Society standards based on the tasks being performed. The light fixtures themselves all appear to be operational, and are in good condition. Other than the replacement of burned out lamps, there should be little maintenance or repair required on these fixtures.

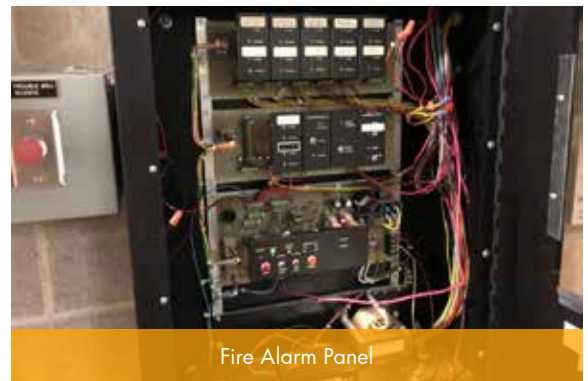
Fire Alarm Panel

The A Wing has an old National Time & Signal zoned fire alarm panel located in the main mechanical room. The panel appears to be functioning properly, however almost all zoned fire alarm panels have been replaced by newer addressable type panels. This manufacturer, while still in business, is not a large manufacturer, and given the age of the equipment, repair and replacement parts on this panel will become more difficult and expensive. Currently, there do not appear to be any significant code violations with the fire alarm system, or any items that would adversely affect occupant safety. However, given the age and condition of the fire alarm system in this wing, and in the B thru F wings, described below, we would recommend that these fire alarm systems be replaced.

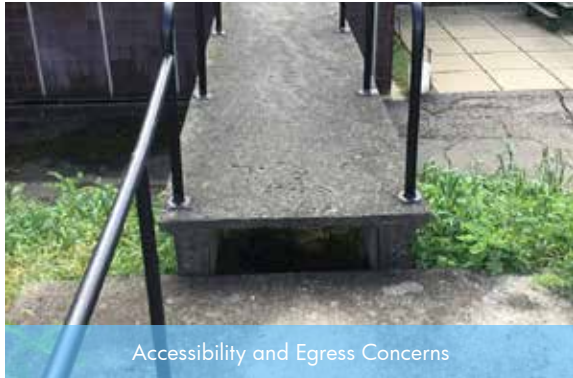
Accessibility and Egress Concerns

None of the emergency egress precast bridges comply with egress requirements. There is approximately a 1' drop-off at the end of the bridge which creates a dangerous condition and is not accessible for someone exiting in a wheelchair. Ideally the landing areas would be elevated to provide an area of refuge at the end of the ramps that is level with the elevation of the ramp. Additionally, the bridges need to have code compliant guardrails to ensure safety. Consider providing new side mounted railings to increase clearance between handrails and enhance maneuverability of someone in a wheelchair. These conditions were not observed in the wintertime, but it can be assumed that these exits become dangerous and a serious liability with the addition of ice and snow.

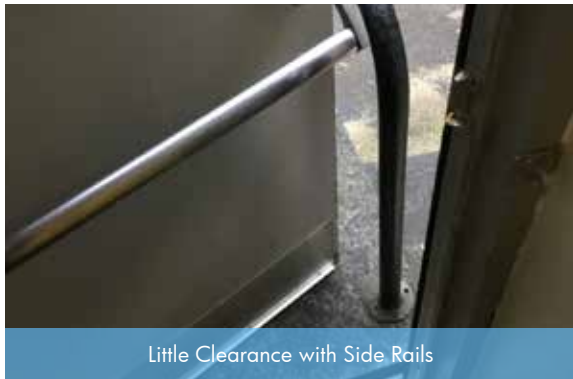
Little Clearance with Side Rails

Some of the emergency egress doors that exit out onto the precast bridges appear to require excessive opening force are extremely close to the railing when they open. There is very little clearance between the door and the side railing. This could block the exit if something damages the railing or gets wedged between the railing and door.

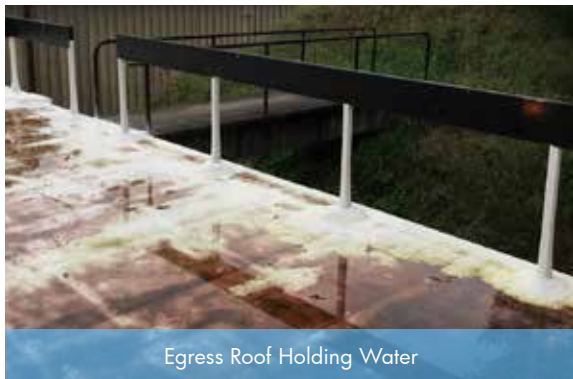
Egress Roof Holding Water

Egress onto existing low roofs from both the weight room and art studio are dangerous. It was noted that the roof surface does not drain well and holds water for long periods of time. The roof surface becomes extremely slippery when wet. At a minimum it is recommended to provide roof walkway pads across the roof from the exit doors to the bridge or stair.

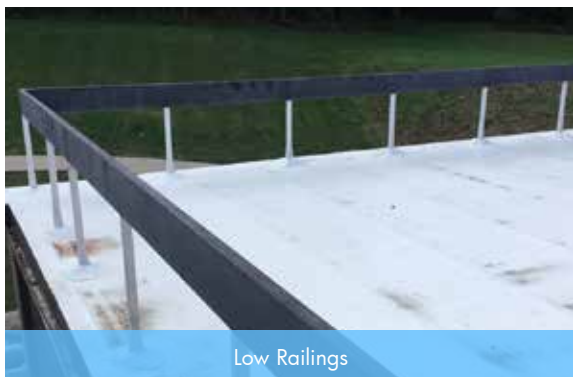
Low Railings

The integrity of the existing railings on the low roofs is compromised due to rust and degradation. Additionally, these railings don't meet the requirements for guardrails. Since part of the path of emergency egress in onto these areas, it is recommended that code compliant guardrails be installed.

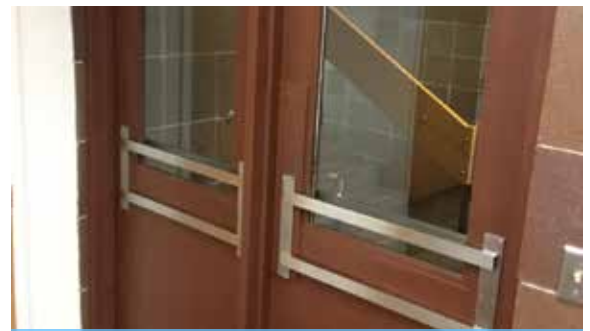
Several fire rated doors were being held open with wedges or other weights. Additionally, the latching hardware is either not functioning properly or has been removed from many of the rated doors in the stairs. Some of these rated exit doors don't have required panic hardware. This hardware needs replaces to maintain the integrity of the rated door.

Missing Panic Hardware

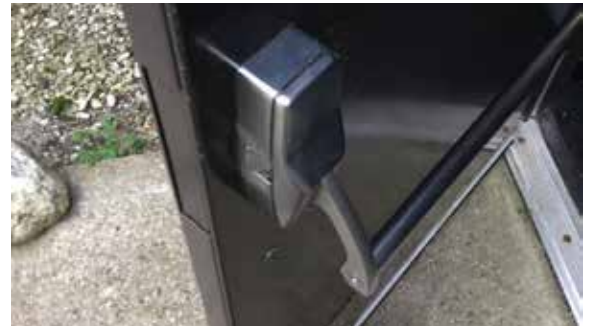
The exit door on the north side of F Wing by the dumpster appeared to either not have functioning latching hardware or was unsecured. It was noted that there are multiple unsecured entry points around the entirety of the building. It is recommended to limit the number of unsecured doors and monitor all doors with either an access control system or campus wide security cameras.

Unsecured Entry

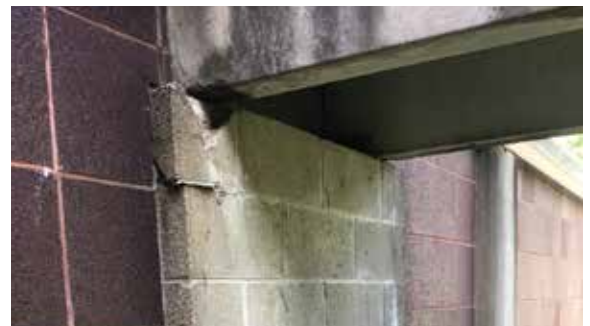
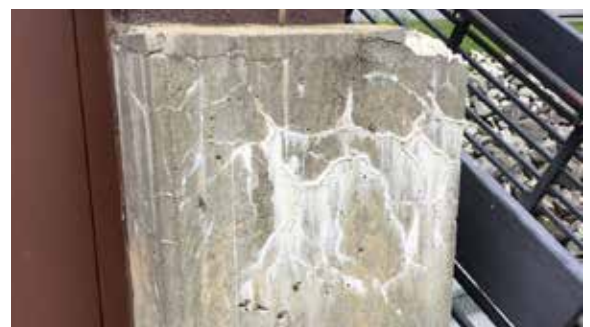
There are a few areas around the building which appear to have some structural degradation. They include the precast T bridge support exit from the north roof, the concrete piers on the north roof adjacent to the pre-engineered building, and the concrete pier on the southeast corner of the south low roof.]

Structural Degradation

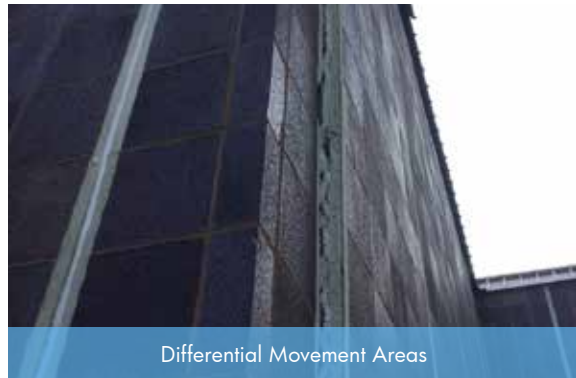
Differential Movement Areas

Typically, the corner joints of the precast panels are areas that have separated the most and have the greatest potential for water infiltration. A possible solution to weather protect the separated corner joints would be to add a cladding at the corners that could cover the joint.

Most of the precast joint caulking appears to be in decent condition except for locations where panels have experienced extreme differential movement. These areas need new backer rod and sealant.

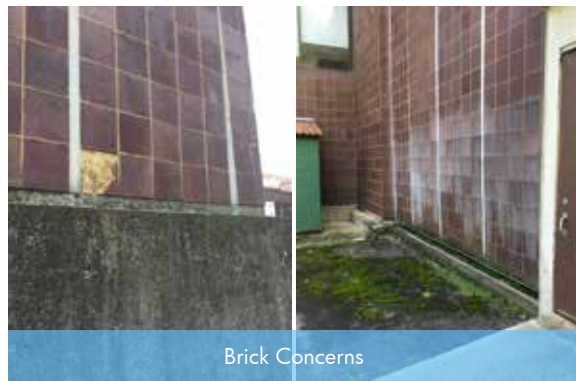
Brick Concerns

There are some thin veneer brick areas that are cracked or have popped off. These areas should either be replaced by adhering a new matching thin veneer tile or using a high performance paint coating to match the brick.

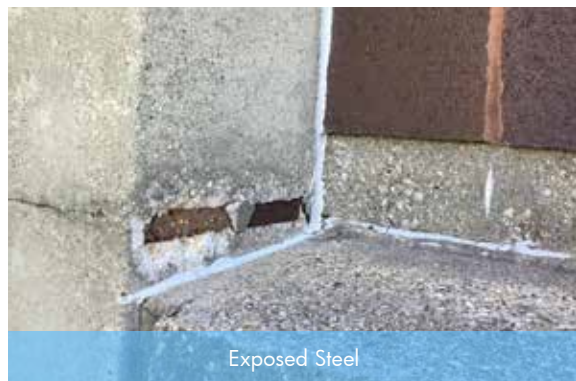
Exposed Steel

Many locations of the steel plates that are buried in the precast columns are now exposed. There was not enough concrete coverage over the steel and it has spalled off. Over time, water penetrates to the steel where it slowly oxidizes creating rust staining and causing the concrete face to spall off. Would recommend prepping and protecting the exposed steel with high performance paint coating and patching the concrete.

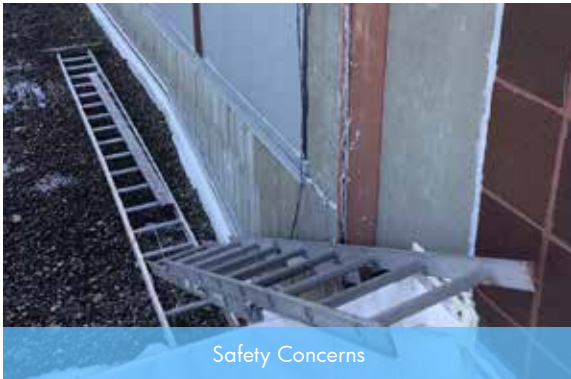
Safety Concerns

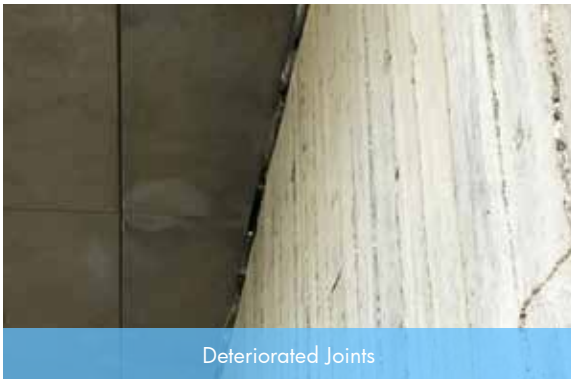
The main area under the concourse has plaster soffits that are in good condition requiring periodic cleaning and re-painting. The soffit to wall joints on the north and south need backer rod and sealant where existing joints have deteriorated. The perimeter soffit joint is to remain open to allow for air flow around the soffit.

Deteriorated Joints

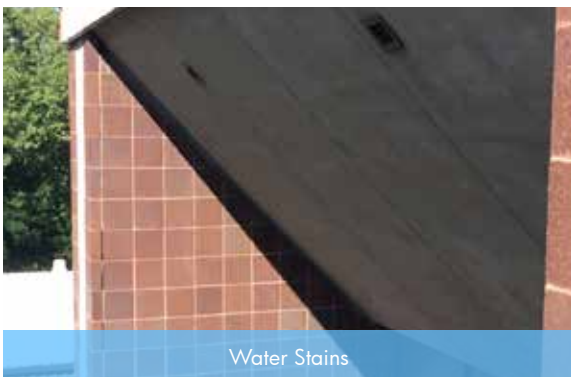
Water Stains

It should be noted that there are numerous locations where the lay-in ceiling tile and plaster ceiling systems have visible water damage. These locations include the following:

While some of these locations are related to obvious issues with the roofing directly above the rooms, some may also be caused by condensation from ductwork and leaking piping. Identifying and repairing the sources of the water damage is important for maintaining a healthy interior building environment.

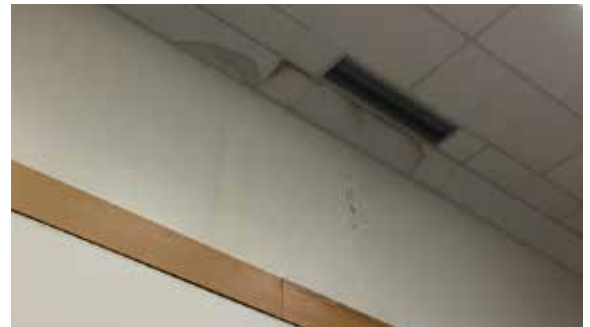
- High ceiling tile in the media center.
- Excessive water damage on high ceiling tile in the art studio.
- Computer Lab E432 contains damaged ceiling tile near the classroom entry and along the exterior wall.
- Plaster ceiling in Boys Locker room B133 was damaged and contains water staining.
- East hallway in B Wing adjacent to locker rooms
- Evidence of water damage on slopped plaster ceilings in stairs. Need to evaluate source of water damage to prevent further damage. Recommend refinishing and repainting plaster ceilings in stairways.
- Miscellaneous isolated locations throughout the building.

Media Center Ceiling

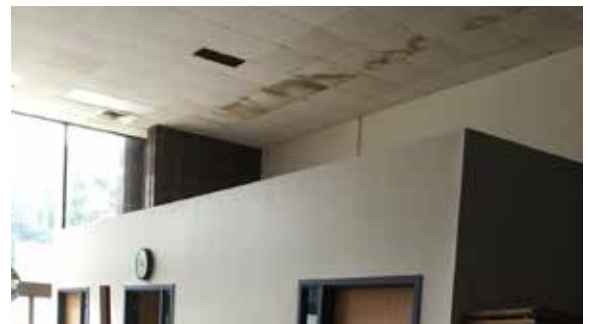
Art Studio Water Damage

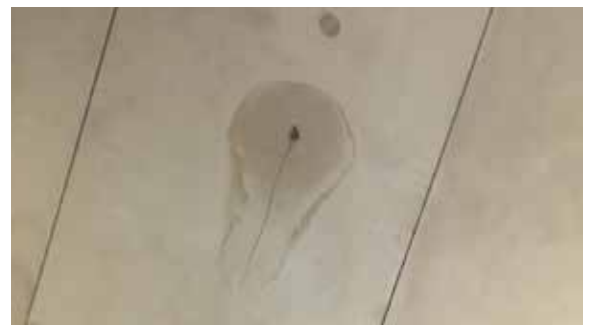
Water Damage

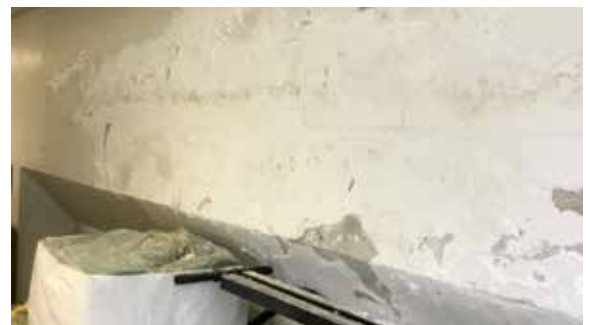
- More aggressive, active water infiltration can be seen at the upper portion of exterior concrete wall in B Wing exit hallway southeast of main gym. This could be a result of water infiltration from the low roof which does not drain well. Finish plaster is flaking off the concrete.
- Brick in stairways has water damage adjacent to treads likely due to clean products and methods used to clear the terrazzo treads

Flaking Plaster

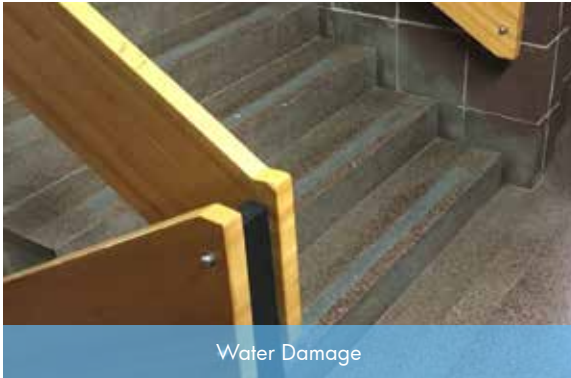
Water Damage

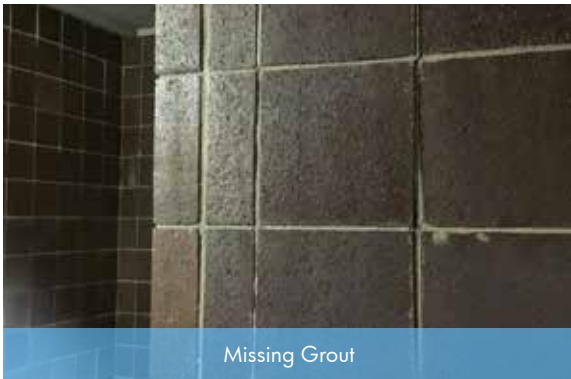
Missing Grout

- While it appears to be minimal, water infiltration can also be seen at some of the interior columns brick walls in the weight room.
- It was observed that there are areas of brick that are missing grout. This was mainly identified in the stairways
- There are some damaged tile in the restroom in E Wing.
- Wall tile staining in locker rooms.

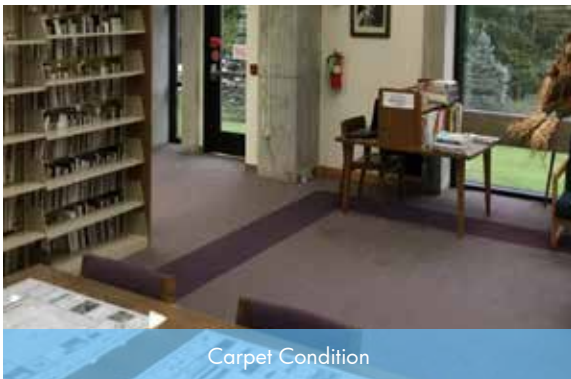
Carpet Condition

Most of the office, and classrooms have broadloom carpeting with some classrooms containing carpet tile. These floor finishes are in good to fair condition as some of the carpet show signs of wear. It is recommended for future office suite and classroom renovations to consider installing carpet tiles in lieu of broadloom. In general, circulation corridors are mainly VCT flooring with some areas of carpeting.

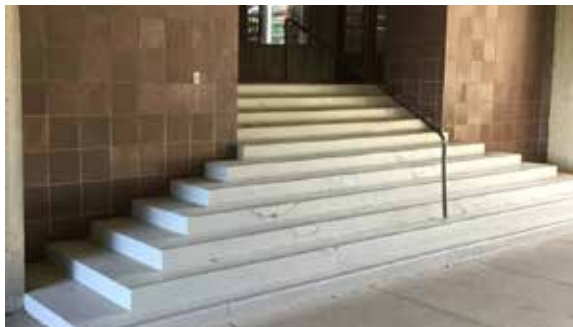
Missing Handrail

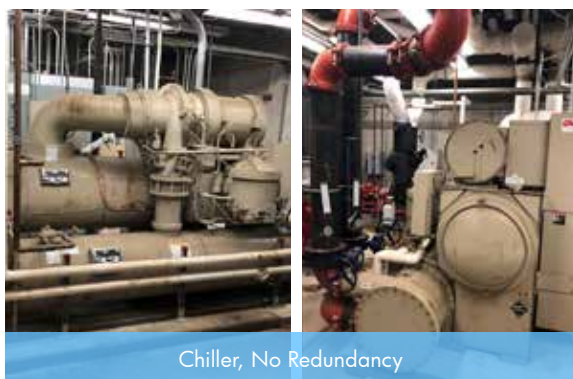
Chiller, No Redundancy

This chiller utilizes refrigerant R-134a and was manufactured in 2008. This is a single chiller for the entire building area, and there is no redundancy on the chiller. A failure to the chiller I would take down cooling for the majority of the building.

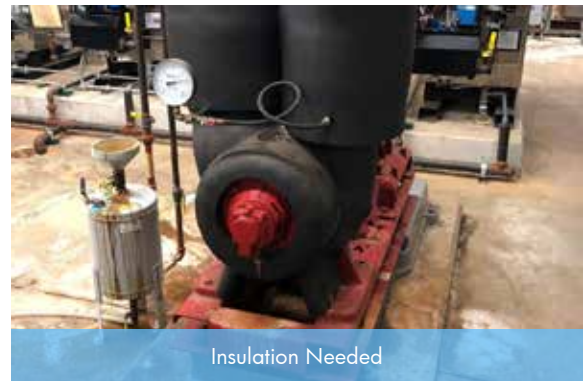
Each pump system has redundant pumps, with the exception of the individual boilers. This would allow each system to keep operating with the failure of a single pump. These pumps have variable frequency drives installed on them mounted on the wall to be able to modulate the flow rates when valves are closing downstream. It should be noted that the chilled water pumps had a large amount of condensation on the pump bodies and piping where some gaps in insulation were found. This insulation should be fixed to help prolong the life of the pumps.

Insulation Needed

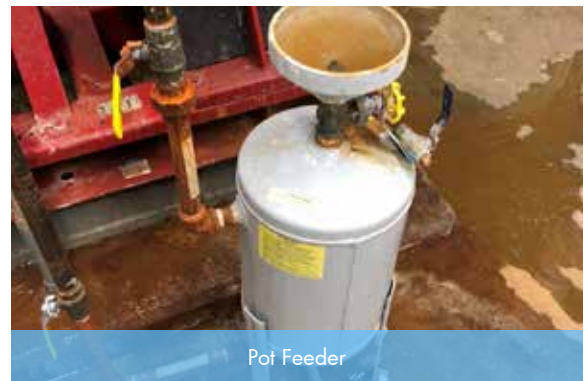
Each main hydronic system has a pot feeder for adding chemical treatment into the systems. The pot feeder for the chemicals to the chilled water closed loop system had a tremendous amount of water on the floor and the filling cone was full. It seems there is a small leak on the system allowing this to fill up into the pot feeder.

Pot Feeder

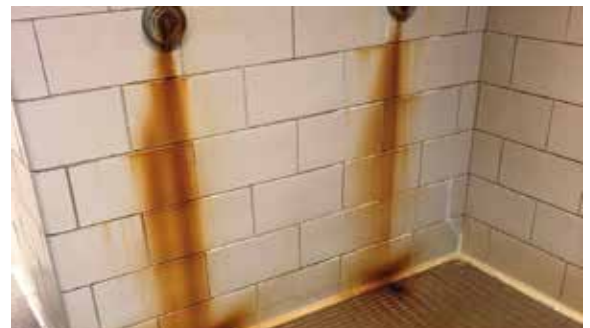
Very few of the original plumbing fixtures meet the current ANSI ADA codes required in new construction.

ADA Compliance Concerns

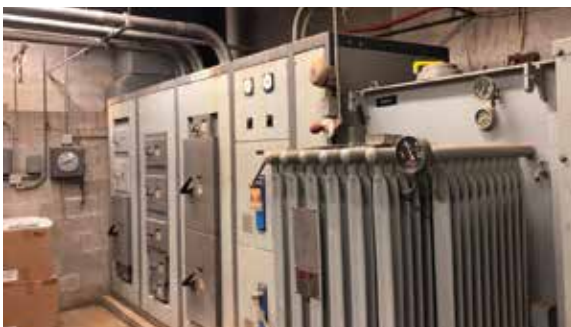
Transformer

At the time of our survey, the load on the 1500 kva transformer and switchgear was approximately 500 amps. This transformer has a full load capacity of 1800 amps, so the electrical service is only load to 25-30% of its capacity. It appears that the 480 volt switchgear is remaining from the original 1967 building construction. Based on that age, although everything is currently operating properly, this switchgear is nearing the end of its expected life. At this age, equipment starts to become unreliable. The fusing inside of the branch switches should still perform properly, and prevent overcurrent on branch circuits, however due to age and heat, springs and other equipment inside of the disconnect switches can become brittle and fail, particularly when the switches are operated. When this happens the switch usually cannot be closed, meaning a large portion of the building would be without power until a replacement switch could be found and installed. In addition, the environment inside the mechanical room

is harsh, and the switchgear is starting to show rust and deterioration.

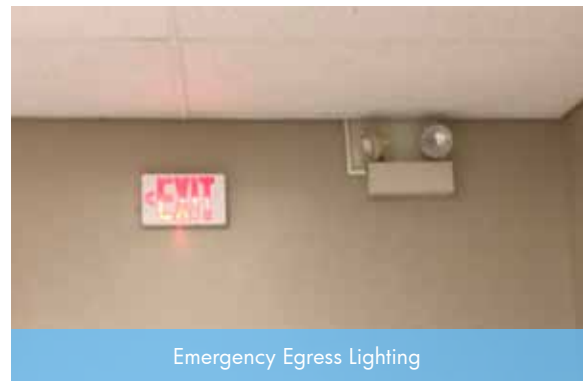
Emergency Egress Lighting

There does not appear to be a generator anywhere on campus to provide emergency power. Emergency egress lighting is accomplished mainly through battery powered, self contained wall mount emergency lights located in corridors and other common areas. In other areas, such as the gymnasium, emergency battery units have been installed in the ballast compartment of selected fluorescent light fixtures to provide emergency lighting upon power loss of normal power. Building codes dictate that emergency lighting must be provided along all paths of egress, and they also spell out the minimum and average light levels required along those paths. There are many areas inside of the B thru F wings that do not appear to have any type of emergency lighting, or if they do it is unlikely that it meets the required light levels. Additional battery powered wall pack units are a cost effective way to provide additional egress lighting, however this also comes with an increased maintenance cost going forward. Emergency lights are required to be tested both monthly and yearly, and for a large building or campus, the maintenance cost of testing all of the fixtures can become prohibitive, or more commonly, the testing does not get performed. As additional units are added, the college may want to consider emergency lights that include a self test feature. These fixtures have internal circuitry that perform the required monthly operational test, and the required yearly 90 minute test. If there are problems, or the unit does not pass the test, then LED indicators on the fixture tell maintenance staff what the problem is. This can greatly reduce maintenance cost on these units, and can also reduce the liability on the College. Another option in addition to self contained battery units would be to add an emergency generator to the facility to power selected light fixtures upon loss of commercial power. This option would be significantly more expensive than adding battery units due to the cost of the generator and the additional wiring required, however the ongoing maintenance cost would be significantly reduced. This option could become more feasible if the generator could also be used for other emergency power requirements, such as networking equipment, coolers & freezers, data centers, or other equipment.

- a. Provide new fire arm system
- b. Provide additional emergency egress lighting in areas that do not meet current code requirements
- c. Provide automatic lighting controls in selected areas where it is cost effective to to install and will provide significant energy savings
- d. Replace existing lighting and circuit panel boards as part of any significant architectural renovations.

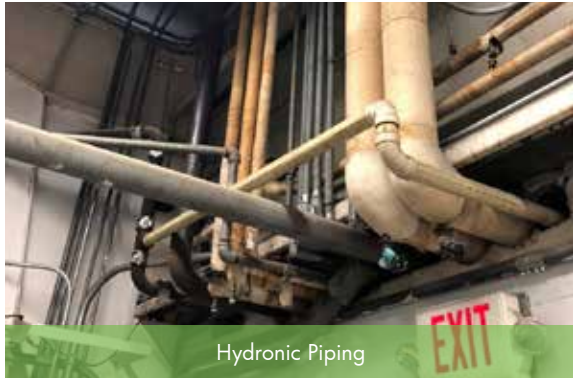
Hydronic Piping

Heating water enters from overhead through the E wing (core) of the building. This hot water piping feeds miscellaneous unit heaters and makeup air handlers. The hydronic piping is all insulated and no real deficiencies exist.

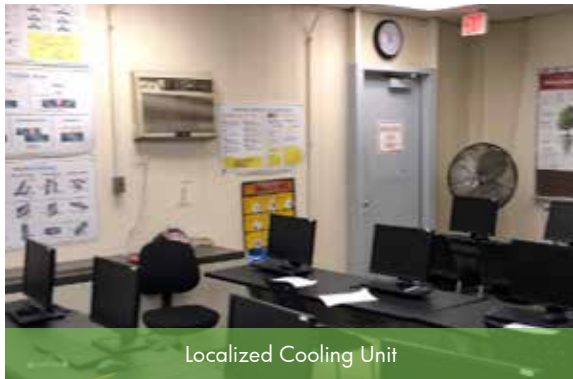
Localized Cooling Unit

There are some localized cooling units that are window air conditioners or mini-split type of systems that provide some cooling in the classroom areas inside these shop classes.

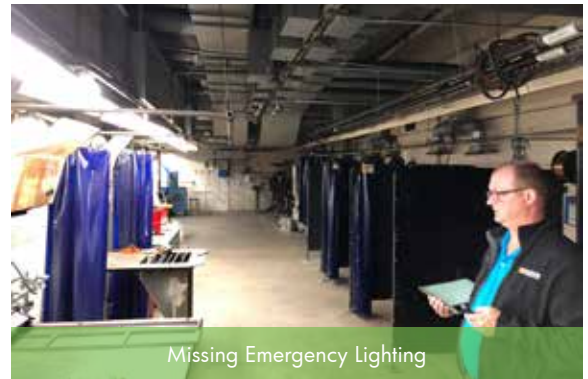
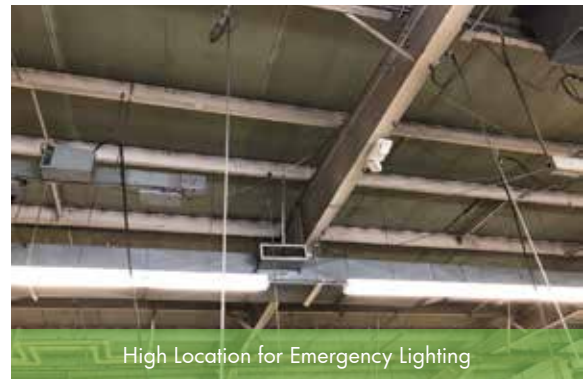
We observed very few emergency light fixtures in the E Wing at the time of our survey. In the industrial arts area, there were some units installed on the building trusses at the ceiling level. Given the height however, these units are very difficult to test and maintain. Given the nature of the work in the automotive and industrial areas, it could not only be an exit issue if normal building power is lost, but it could also be a serious safety issue for students operating machinery.

- Provide new fire arm system
- Provide additional emergency egress lighting in areas that do not meet current code requirements
- Provide automatic lighting controls in selected areas where it is cost effective to to install and will provide significant energy savings
- Replace existing lighting and circuit panel boards as part of any significant architectural renovations.

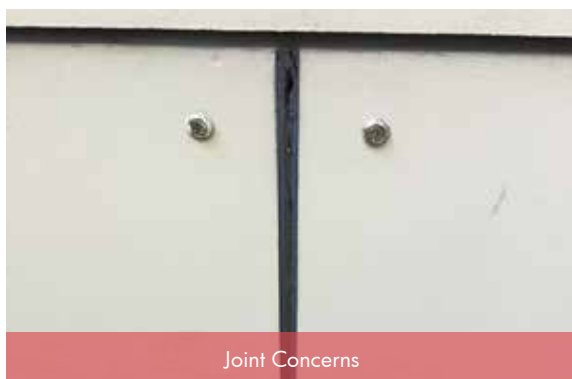
Joint Concerns

Many fiber cement panels have cracked within the vicinity or in close proximity to fasteners. This could be a result of overtightening the fasteners or not providing an oversized hole. Either one would restrict the movement of the panel due to thermal changes and cause the cracking to occur.

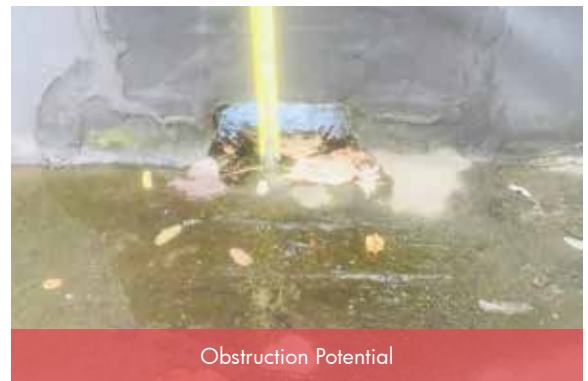
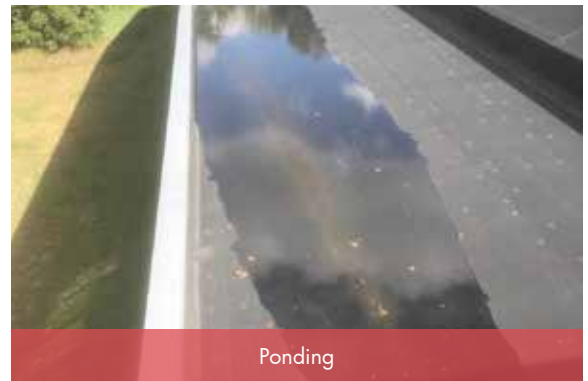
No issues were observed regarding the installation of the roof membrane itself, however the through-wall overflow scupper on the high roof does not meet code due to its small through wall opening size. Per section 1503.4.2 of the IBC, scupper dimensions shall not have an opening dimension of less than 4 inches in any direction. The scupper on the high roof is less than 3" tall. It is recommended that the scupper opening be modified to minimize the potential for this opening becoming obstructed, especially since this scupper opening is the primary outlet to drain this roof level.

Ponding water was observed on the north portion of the lower roof. It appears the primary roof drains are partially clogged since dripping water was observed coming from the through wall overflow discharge piping along the north side of the building at finish grade. Periodic evaluation of the drains is recommended to ensure the primary drains are kept clear.

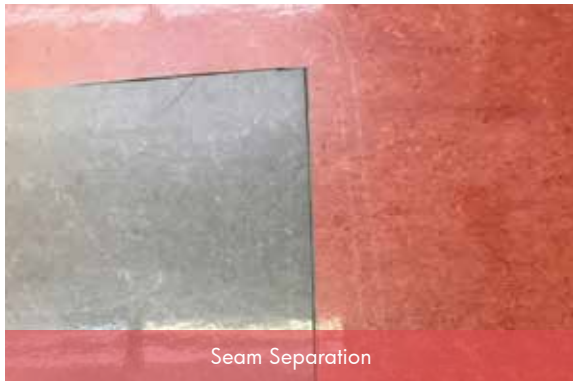
Seam Separation

Flooring in the 2005 science addition is in good condition. The hallways are sealed concrete with the lobby space having a combination of sealed concrete and carpet. The classrooms and offices have carpet flooring. The science labs have resilient sheet flooring. There are a few locations in the science labs where the resilient flooring seams are starting to separate.

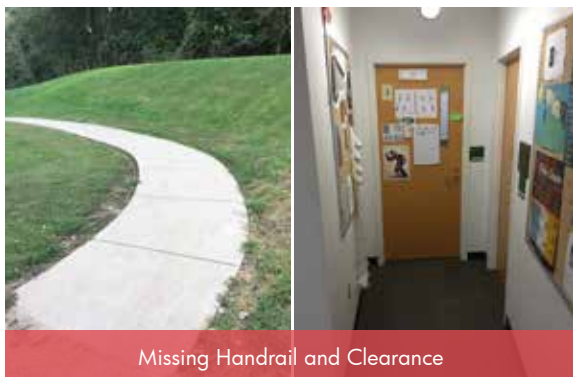
Missing Handrail and Clearance

The ramp on the southwest side of the building leading up to G Wing appears to have a slope greater than 1:20 which would officially classify it as a ramp and not a sloped walkway. By code ramps are required to have handrails on both sides. If slope is steeper than 1:20 handrails need to be added for code compliance.

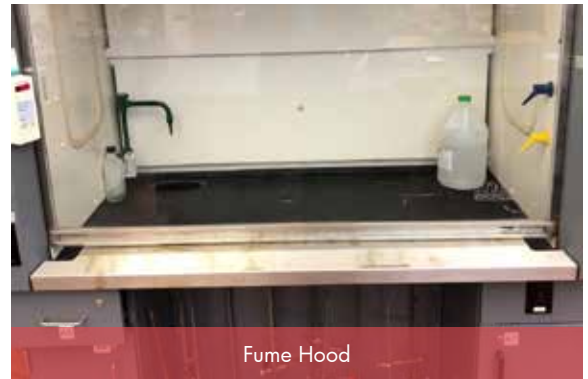
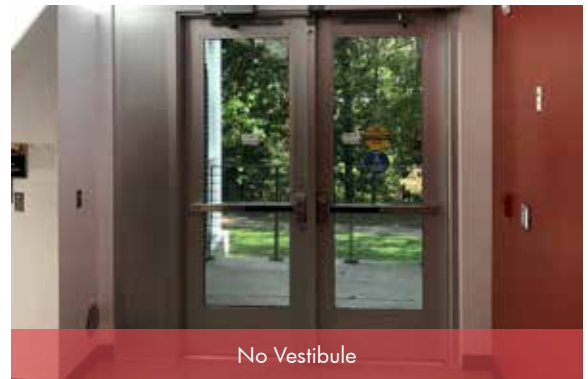
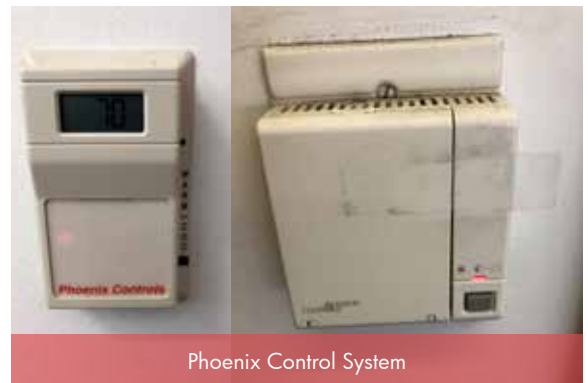
The area has a Johnson Controls direct digital control system (DDC) installed and it appears to be operating properly. No visible defects were apparent. The software should be continuously checked to make sure updates are installed to have current security patches installed.

The Phoenix control system for the lab spaces appeared to be working well. There should be a plug in to get this system integrated with the campus Johnson control system. [IMG_2117] [IMG_2147]

- a. Add redundant condensing boiler to eliminate single point of failure and increase efficiency
- b. Repair refrigerant piping insulation and jacket over the insulation on the exterior of the building
- c. Install VFD on hot water pumps with premium efficiency motors on pumps to reduce energy
- d. Close bypass valves on 3 way valves at terminal boxes
- e. Install air curtain heaters at main doors to prevent cold air from entering building in winter and losing energy
- f. Install key security patches for the Johnson Controls system

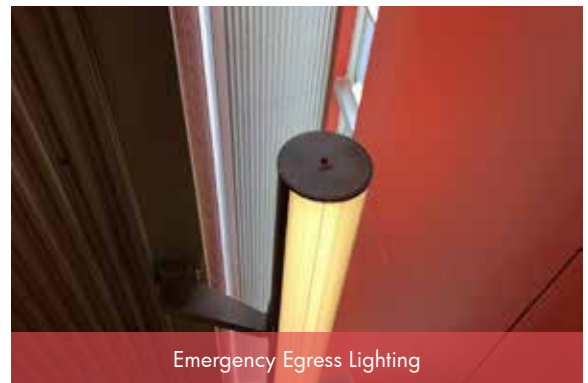
Emergency Egress Lighting

In the G Wing, emergency egress lighting is accomplished through a combination of wall mounted, battery powered emergency fixtures, and through battery units installed in the ballast compartment of selected corridor fluorescent fixtures. If working properly, these appear to provide adequate egress lighting, however the quantity of units and accessing them will continue to be a maintenance issue. In addition, there does not appear to be any emergency egress lighting on the exterior of the building. This is not an immediate safety issue, but it should be addressed as part of any building renovation.
